Fatality #15 - August 2, 2004
Fall of Roof or Back - Underground - KY
Reedy Coal Co. Inc. - Mine No. 25

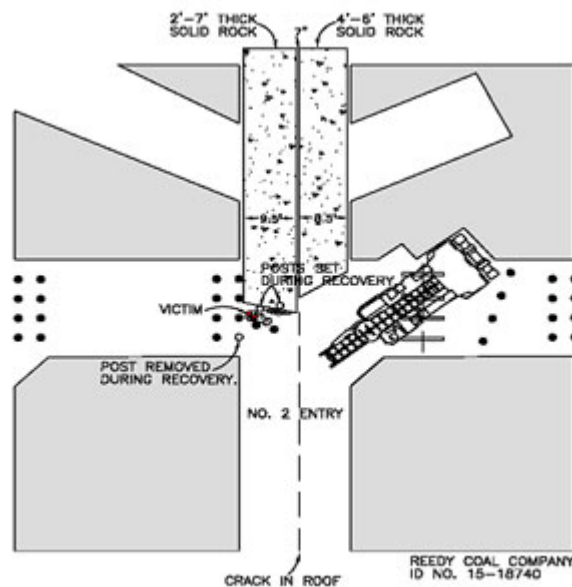
COAL MINE FATALITY - On Monday, August 2, 2004, a 38-year old roof bolter operator with 14 years mining experience, was fatally injured when he was struck by falling roof rock of undetermined length, 18 feet wide, and 0-60 inches in thickness. The victim was working with the section crew and had been installing timbers during retreat mining, shortly before the accident occurred. The victim was located inby the turn timbers, in the number 2 entry, observing the roof conditions for the continuous miner operator, when the roof suddenly fell.

- Ensure that the provisions of the approved Roof Control Plan are understood and followed by all miners.
- Ensure that miners are not needlessly positioned near the pillar line or inby turn posts.
- Be alert for changing roof conditions and install additional roof supports where necessary.
- Apply additional safety procedures or precautions in areas where geological changes and anomalies in strata, such as cracks, are observed.
- Conduct a thorough examination of the roof, face, and ribs immediately before any work is performed and thereafter as conditions warrant.
